### ENG Safety...A Long and Winding, but More Positive Road

By Mark Bell, President, Safety Awareness/Certification Associates/  
engsafety.com

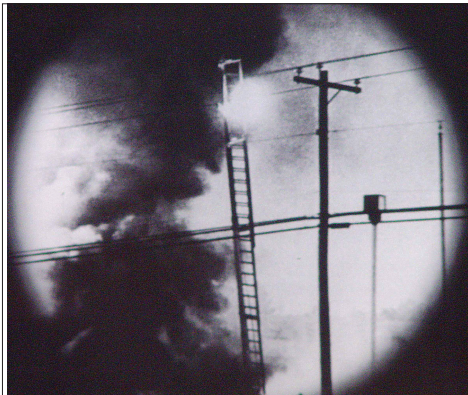
**Figure B.1** This photo, from a government safety manual, demonstrates what happens when an aluminum fire ladder touches a high voltage power line, most of which are not insulated. ENG microwave masts have the same conductive characteristics as this ladder.

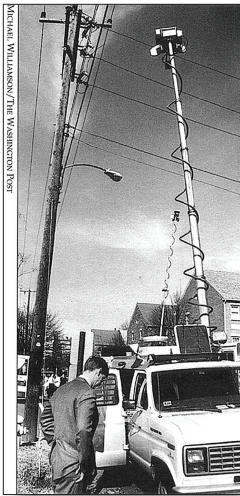
**Figure B.2** This was the truck in which an early ENG tragedy occurred in which a technician died, the picture shot shortly after his electrocution. The picture illustrates the view one can have if standing a short distance from the van and looking at the overall "workplace" or "work environment." This hazardous workplace was created the moment the truck parked, as the van's clearance was certainly not anywhere near the mandated 10 foot clearance from overhead lines 0-50kV. The mast in the rear of the picture is from a van, which was parked across the street, well clear of the power lines. "Across the street from lines" is a great way of maintaining clearance.

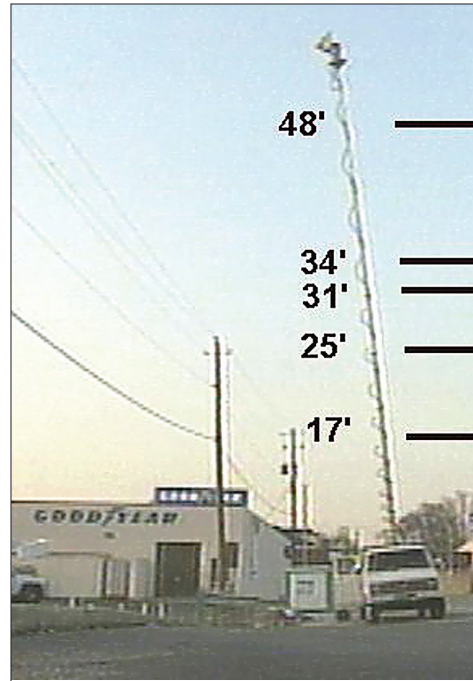
**Figure B.3** This picture illustrates approximate mast heights and voltages on high voltages lines at those heights. Having the ability to reach these hazardous voltages with conductive material is a large, public service, responsibility.

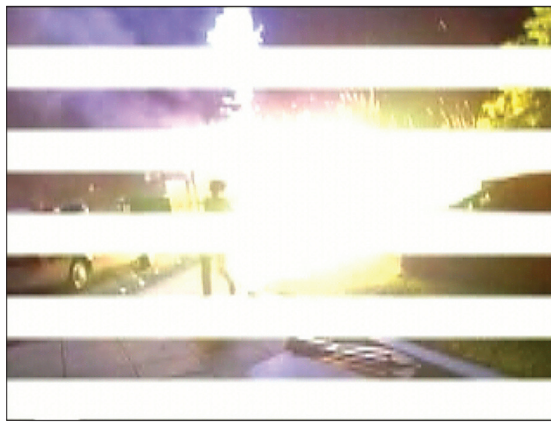
**Figure B.4** In one of the most stunning video frames from any recorded accident, a terrified reporter runs from her electrified news van, seconds after jumping out a short time after the mast had been placed into contact with a 115,000 volt power line. The power line was de-energized right after the initial contact by its circuit breaker, perhaps saving her life. It automatically reset 15 seconds later resulting in a second explosion, pictured here.

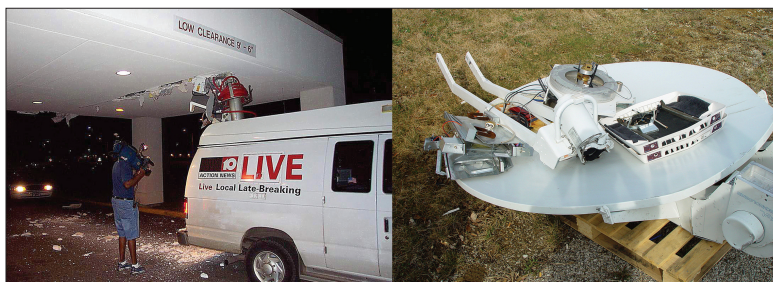
**Figure B.5** Clearance accidents occur much more often than any other type of ENG/SNG incidents. Although these mishaps can also cause a threat to life, they most often cause property damage, and damage to one's career. The ENG truck on the left had its mast down, but that was still not low enough to clear this 9'6" hotel canopy. ENG/SNG operators need to know their "on-the-road" clearance. The right photo shows a KU dish that got sheared off a SNG truck when that truck took off with the dish still up.
